# Technical Bulletin

Model(s)	Year	Eng. Code	Trans. Code	VIN Range From	VIN Range To
(A5) Jetta	2005 - 2006	1.9L (BRM)	Manual	All	All

30 07 01 Nov. 1, 2007 2016615

### Clutch, Friction Material Flaw (SACHS Only)

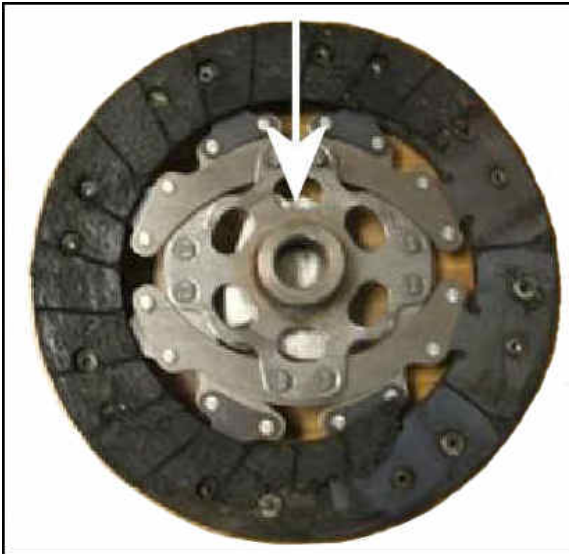
## Identifying clutch disc supplier

Clutch plate supplier name will be found in this area.

Please note missing clutch plate material. This is a possibility of what may be observed when servicing.

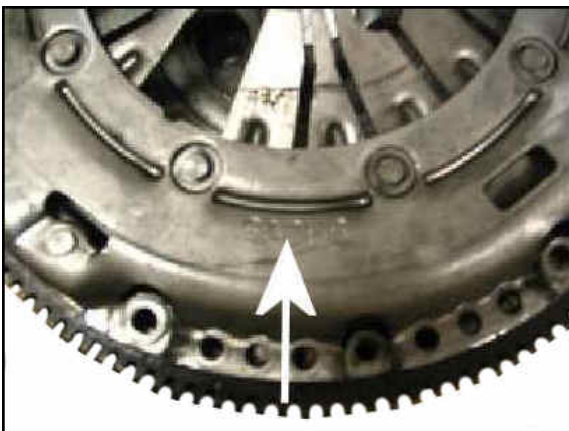
## Identifying Pressure Plate Supplier

Pressure Plate supplier name will be found in this area.

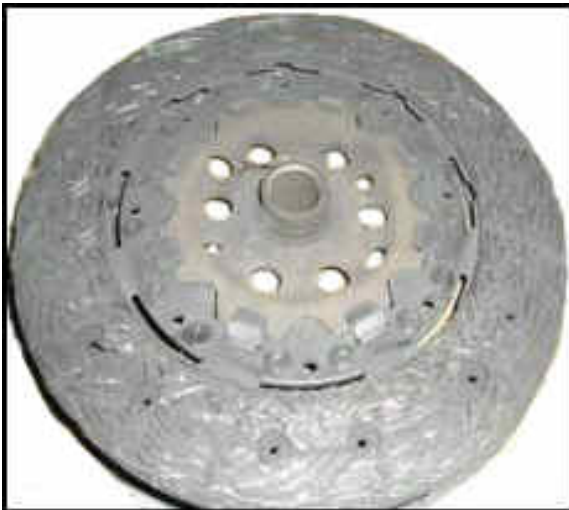
Clutch plate material burnt.

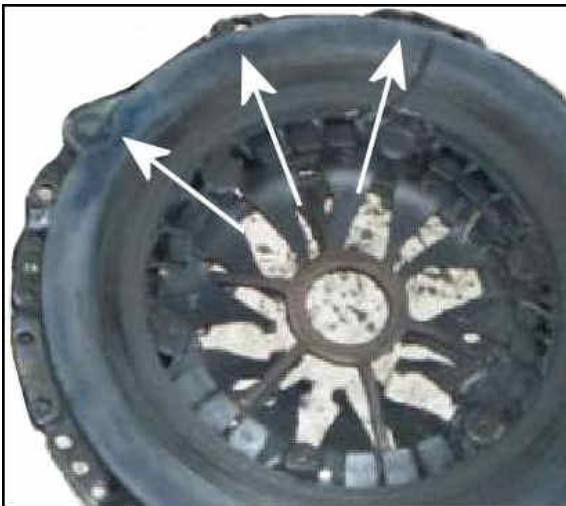
Blued heat spots on pressure plate contact surface.

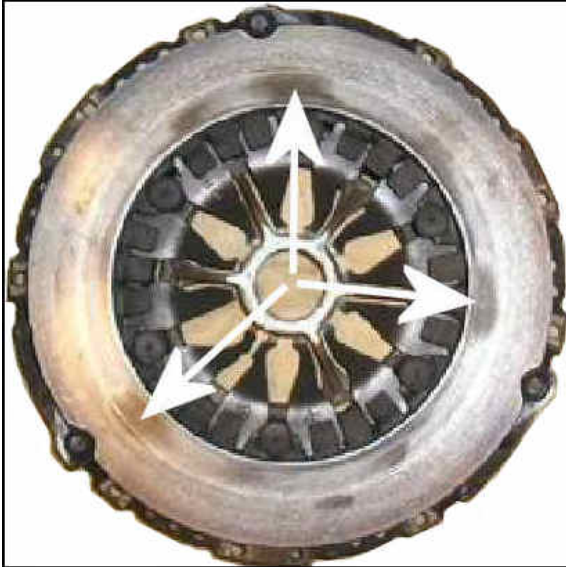
Heat spots on pressure plate contact surface.
